Tiogue Lake

Bacteria Source Investigation

Town of Coventry, RI

AUGUST 2022

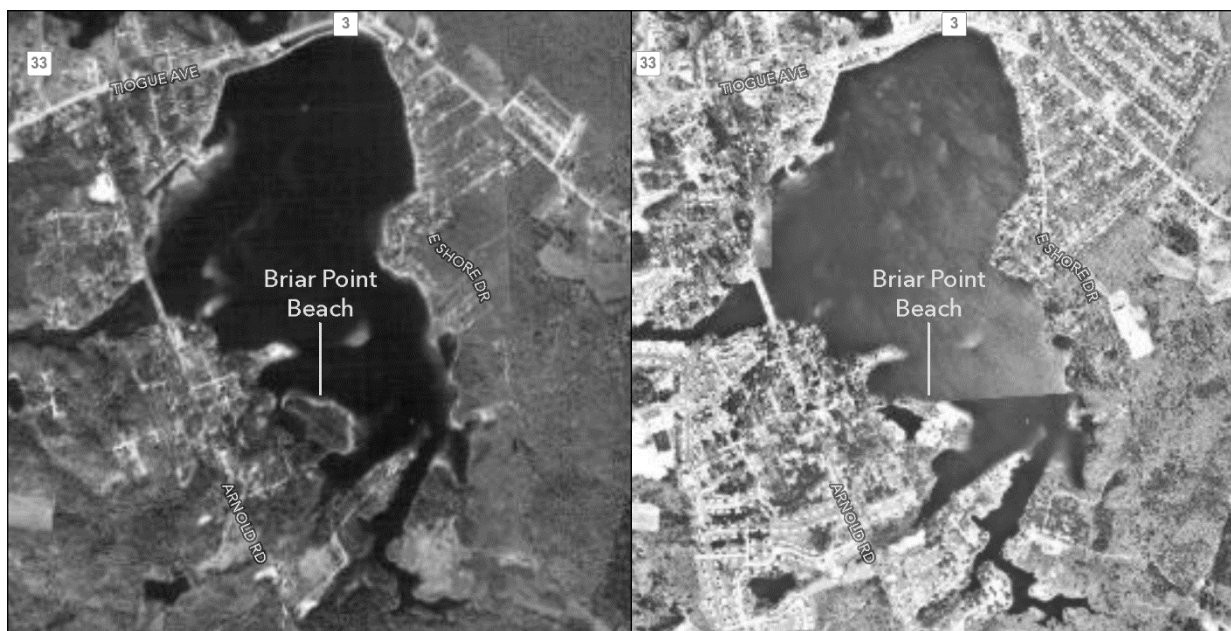
Figure 2: Tiogue Lake in 1952 (left) and substantially built out (1972)

Tiogue Lake is a reservoir created in the 19th century by a stone dam to serve nearby mills along the southwest branch of the Pawtuxet River. The lake outlet flows north toward the Pawtuxet River under Tiogue Avenue. The watershed draining to Tiogue Lake is substantially built-out, with most development occurring between 1952 and 1972 (*Figure 2*). Based on available aerial imagery, many lakeside homes were constructed prior to 1952, and some prior to 1939. Conventional concrete tank septic systems were not developed until the 1950s and so may not be present on lots with these early constructions, which may be served by cesspools.

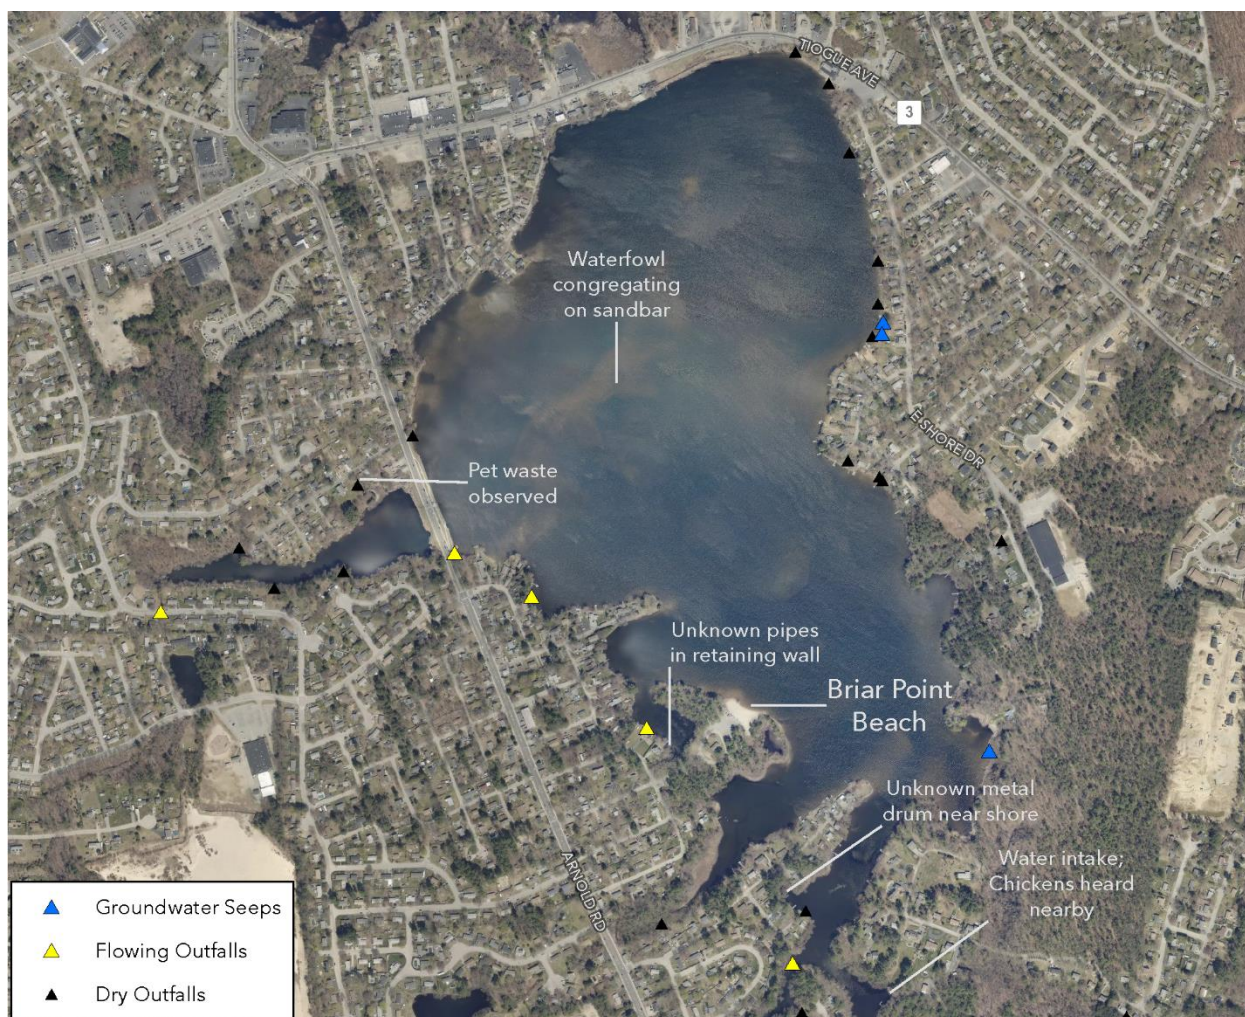
The sanitary survey identified several locations where flow was observed entering the lake, as well as potential locations where bacteria and other pollutants could reach the lake via overland flow (Figure 4). The most common observation during the sanitary survey was pipes located in retaining walls, none of which were flowing at the time of inspection, but which may represent weepholes or yard drains to provide an outlet for groundwater. Field notes and data sheets are included as Appendix A.

Figure 4: Potential enterococcus sources identified during sanitary survey

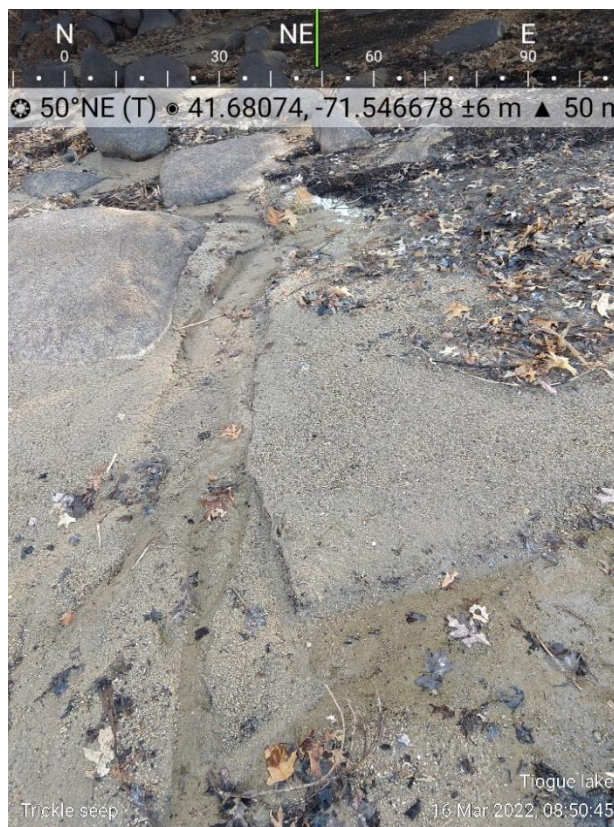
Two groundwater seeps showed enterococcus concentrations below the BAV. The seep in *Figure 5*, located between 95 and 107 East Shore Drive, had enterococcus concentrations over 400 CFU/100mL, or about 7 times higher than the BAV. This bacteria level suggests a source of bacteria to groundwater, such as a failing or poorly-sited septic system or cesspool. Because the sanitary survey occurred when the lake was drawn down and during the high groundwater season, it is difficult to determine if this groundwater seep contributes to enterococcus exceedances in the summer, when groundwater is typically lower. If this seep, and groundwater sources more generally, were substantially contributing to enterococcus levels at the beach, the water quality monitoring data would likely show this impact with more consistent BAV exceedances. Lake water samples collected nearer to the seep would be more likely to show elevated enterococcus concentrations.

Figure 5: Groundwater seep identified at 95-107 East Shore Drive, with high enterococcus concentration

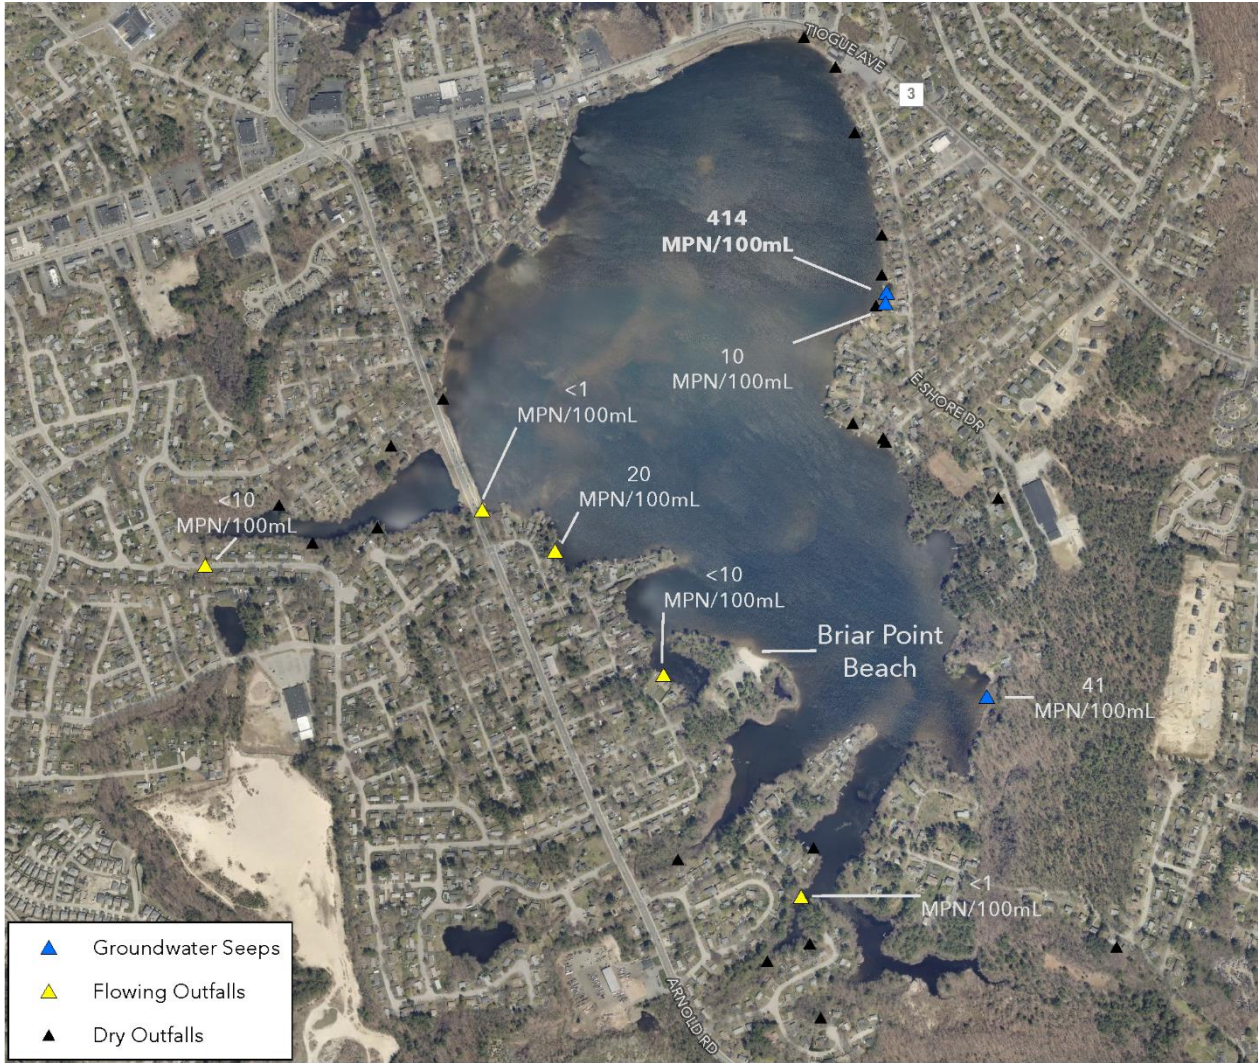
Figure 6: Dry-weather Enterococcus sampling results from late March. Enterococcus concentrations in MPN/100mL, equivalent to CFU/100mL health standard

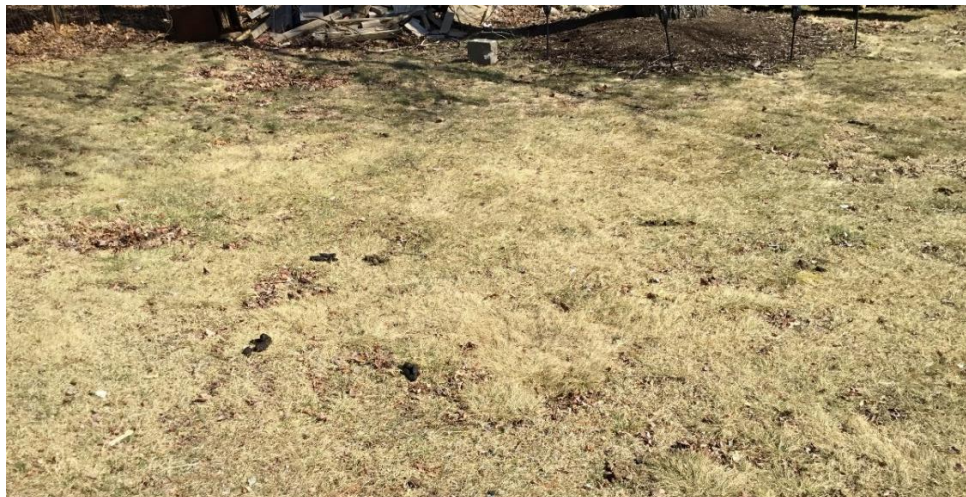
The sanitary survey identified five of twenty-six stormwater outfalls exhibiting flow during dry-weather conditions, samples of which were collected during the return visit. All but one flowing outfall did not have a detectable enterococcus concentration; the outfall with detectable enterococcus was 20 CFU/100mL, below the BAV (*Figure 6*). The outfall on Twin Lakes Avenue was inundated, and during inspection of the first upstream drainage structure, a substantial amount of dog waste was observed on one private property on Twin Lakes Avenue (*Figure 7*).

Figure 7: Seventeen dog waste piles were observed at time of inspection on one property along Twin Lakes Avenue

The Town has already taken steps to reduce bacteria from entering the lake, by enacting ordinances requiring dog walkers to pick up pet waste and forbidding park and public space users from feeding wildfowl. It has posted signage to those effects along the Arnold Road causeway, at Briar Point Beach, and the town boat launch on Tiogue Avenue. Pet waste bags and trash bins should continue to be made available in public spaces near the lake, and Town enforcement staff should continue to enforce those ordinances. Installing educational signage showing the link between pet waste, feeding wildfowl, and beach closures may encourage additional compliance with the ordinances.

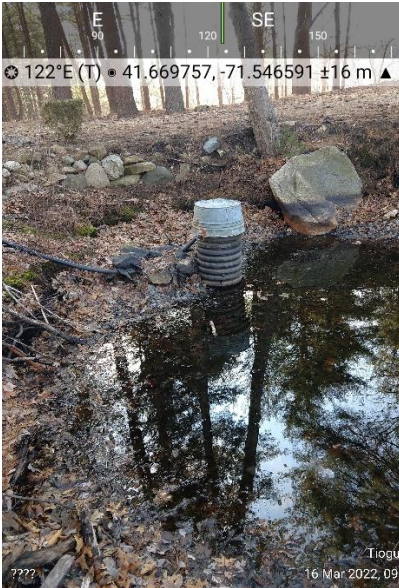
Figure 8a: A suspected water intake located south of Tiffany Rd

A corrugated metal pipe with a connected two-inch hose was identified along the shore south of Tiffany Road (*Figure 8a*). It is suspected that this is a water intake structure. While documenting this structure Fuss & O'Neill staff heard chickens nearby. The water intake and sound of chickens suggests a nearby hobby farm. Hobby farms and the livestock they contain generate animal waste. Proper management of this waste is important to prevent waste transport into surface waters via stormwater runoff.

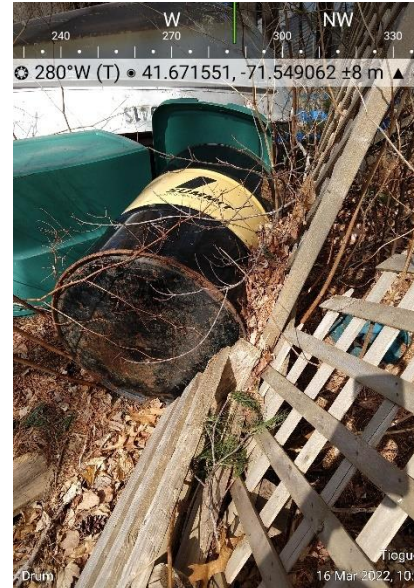
Figure 8c: A drum containing an unknown liquid was observed in a waste pile at approximately 27 Harrington Rd

An unlabeled 55-gallon drum marked with Summit Industrial Products (*Figure 8c*) was observed to be stored along the lake shore on Harrington Avenue. Summit Industrial Products appears to produce chemical degreasers, industrial lubricants, and hydraulic fluids. While these are not sources of enterococcus bacteria, storage of such waste products or reuse of a container that may contain residual waste near the lake shore presents other risks that can be mitigated with adequate disposal in a permitted facility.

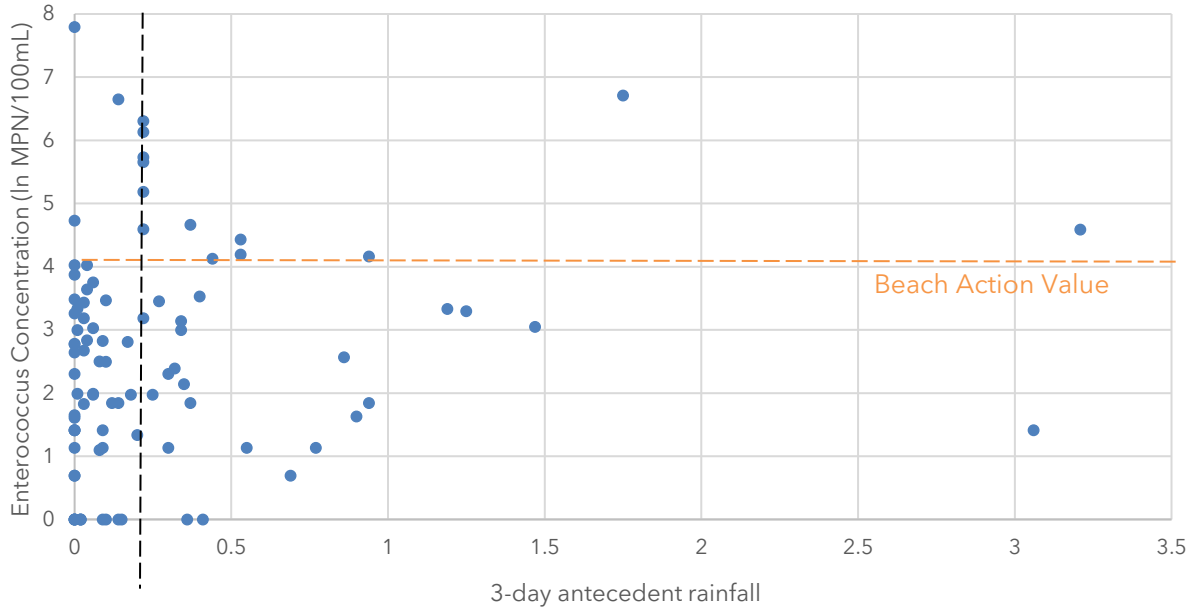
Plotting bacteria monitoring results against antecedent rainfall suggests not all rain events are necessarily followed by an increase in enterococcus concentration at Briar Point Beach. *Figure 10* indicates that enterococcus concentrations above the BAV most often occur after approximately 0.2 inches of precipitation have fallen in the preceding 3 days. Exceedances of the BAV do tend to follow

particularly larger rain events (Table 2). This relatively low amount of rain indicates a brief window following a rain storm where exceedances of the BAV may occur. These exceedances may only be observed by chance in water quality monitoring data when water samples happen to be collected during that window.

Figure 10: Antecedent precipitation and subsequent fecal indicator bacteria concentrations

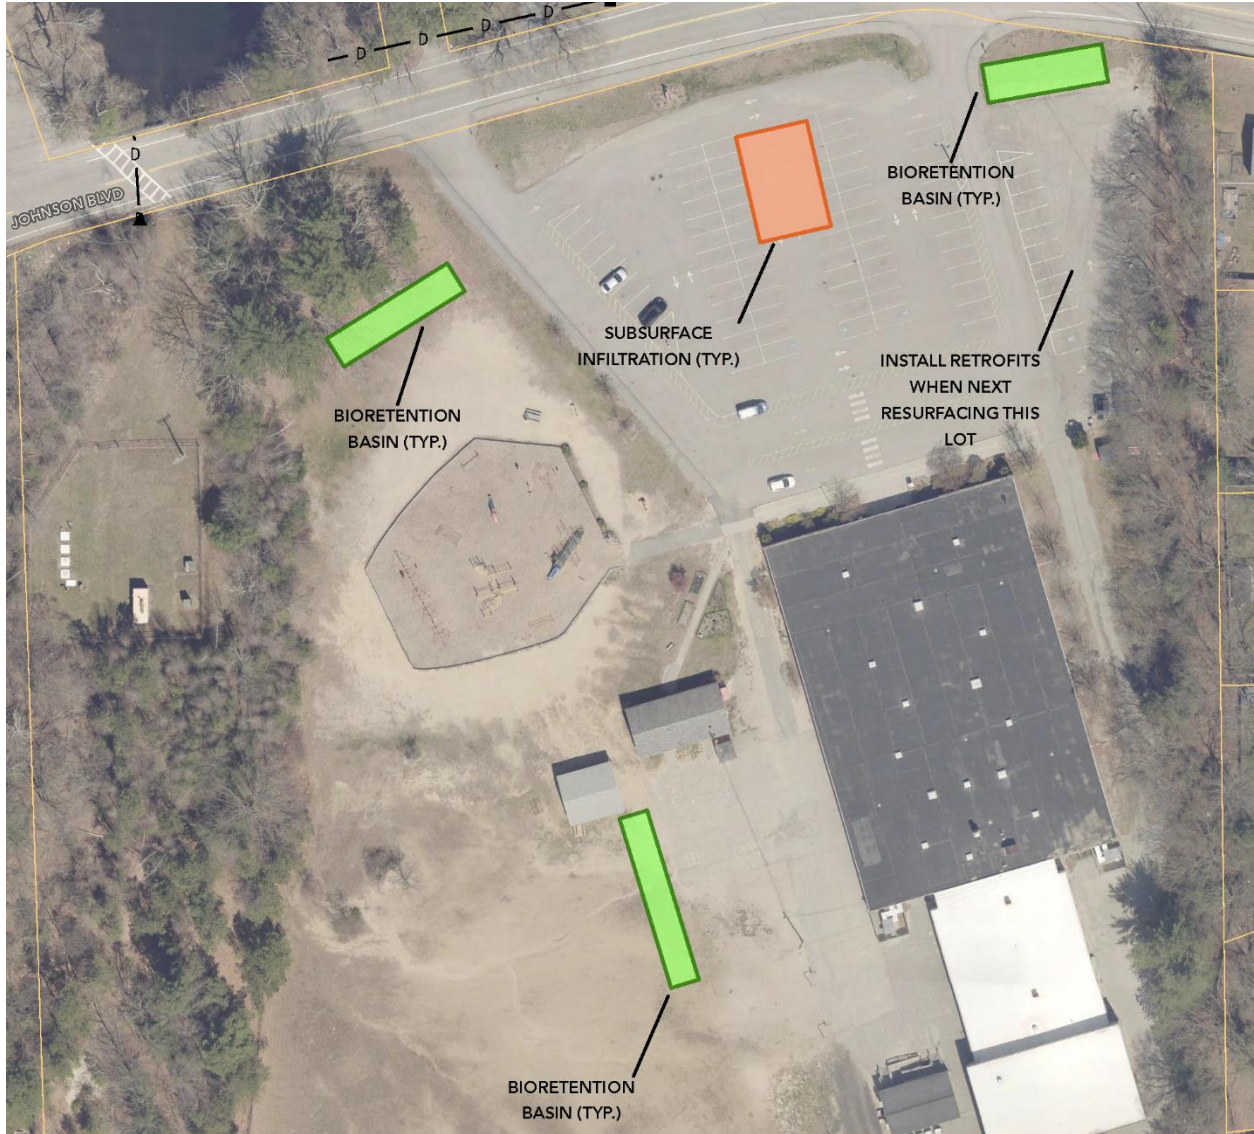
Figure 12: Potential GSI options at Hopkins Hill Elementary School. Aerial imagery and site visits indicate that channelized flow from the playground and impervious area near the pavilion discharges to a direct tributary of Tiogue Lake

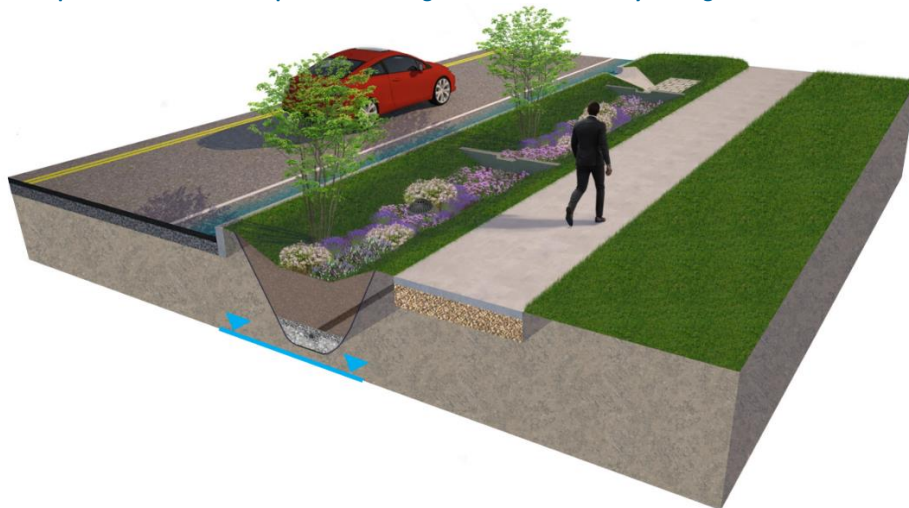
Figure 13: Bioswales between roadway and sidewalk or private property

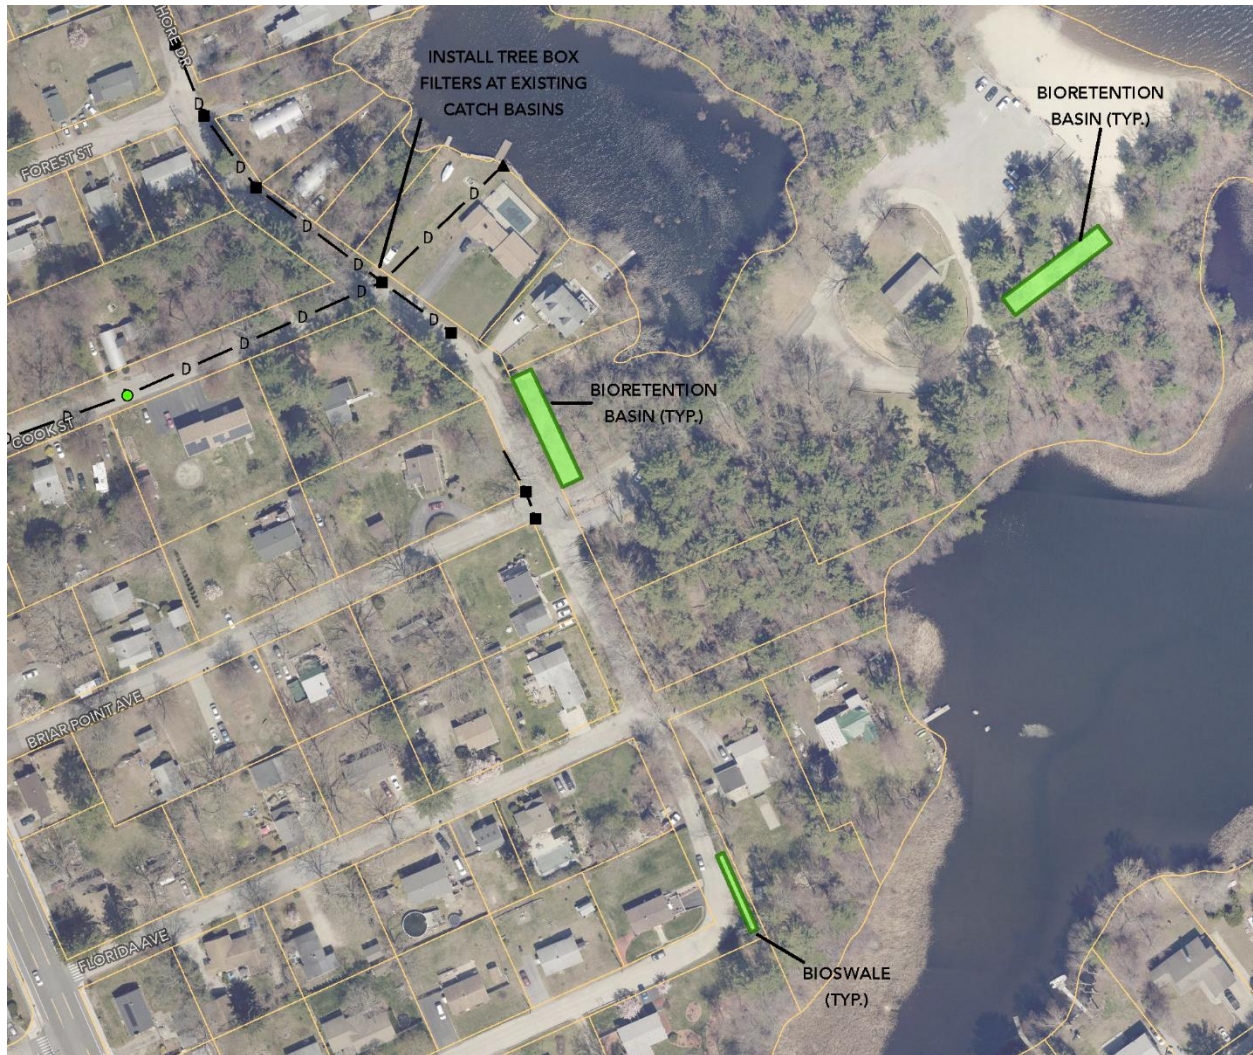
Figure 14: Potential GSI retrofit options within the ROW and on Town property near Briar Point Beach. An unmapped paved swale discharges surface flow from the southeast corner of West Shore Drive directly to Tiogue Lake

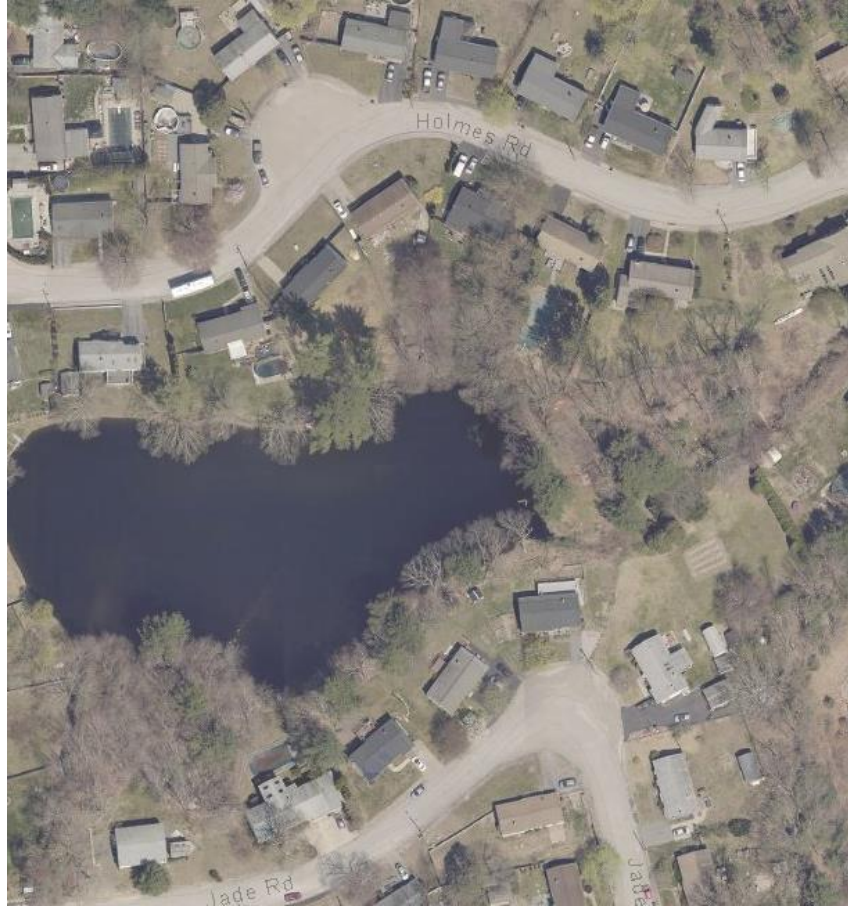
In addition, on the west side of the lake, a common development feature provides additional GSI opportunities. Holmes Road, Cove Road, Colonial Road, York Drive, Jade Road, and Lawnwood Road each have a partial cul-de-sac, also known as a street knuckle, with excess pavement that generates stormwater runoff and pollutant loading without the benefit of allowing through traffic (*Figure 15*). Removing some excess pavement and extending driveways and maintaining existing vehicle access and driveway width would reduce pollutant loading and stormwater runoff, while providing space in the ROW for additional GSI opportunities. This type of project may not change ROW boundaries or property lines, and so can likely continue to comply with the frontage requirements in the Town's zoning ordinance. Additional considerations for these types of solutions include identifying snow plowing and driveway repair responsibilities between the Town and individual homeowners. A similar project addressing recurring flooding is currently underway in Warren, RI (*Figure 16*) using funding from the Rhode Island Infrastructure Bank (RIIB).

Figure 15: Examples of partial cul-de-sacs on Holmes Road and Jade Road

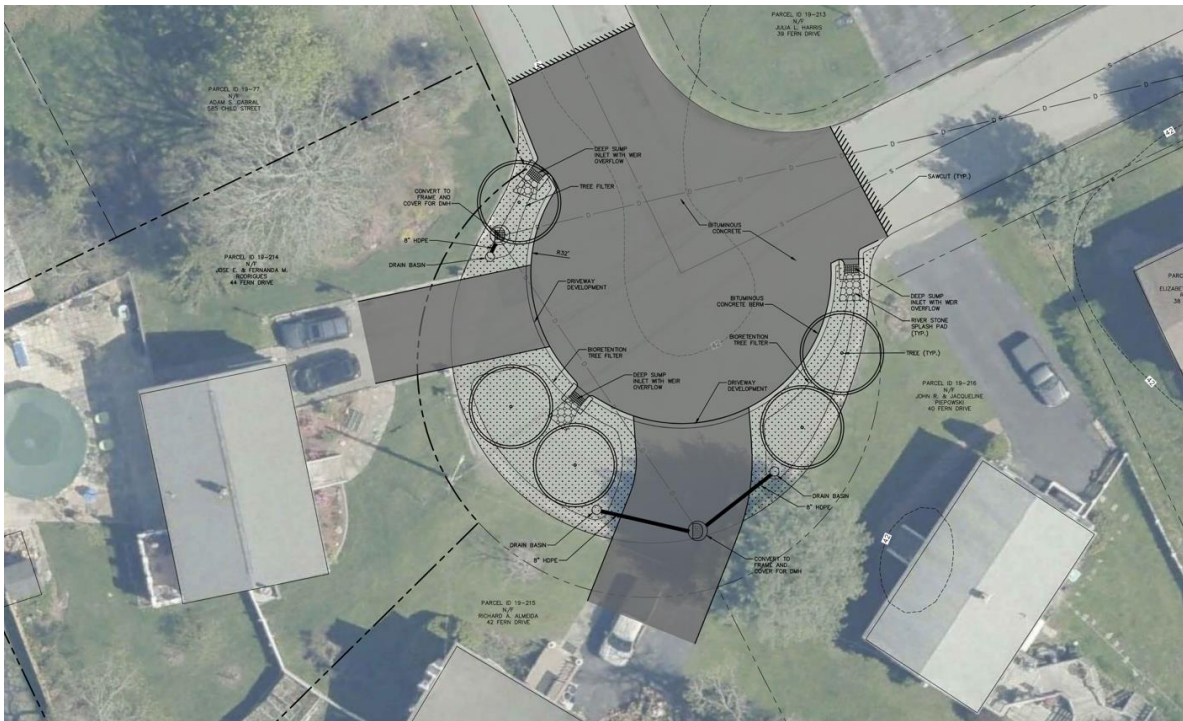
Figure 16: Partial cul-de-sac pavement removal and GSI project example in Warren, RI

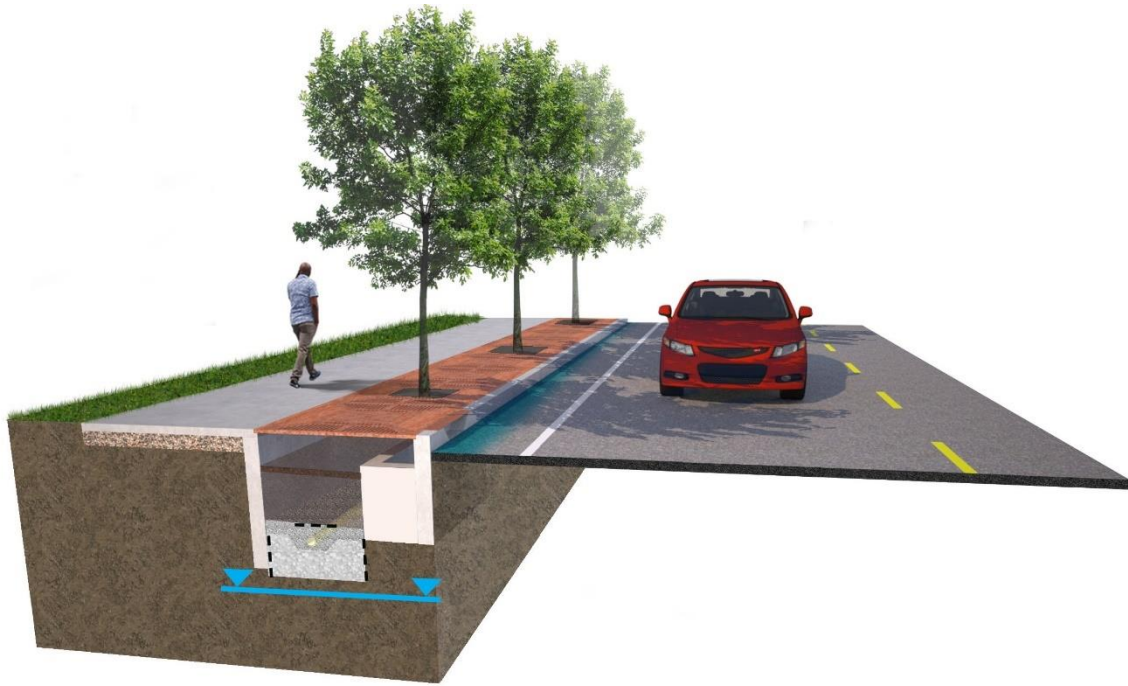
Tree box filters next to roadway

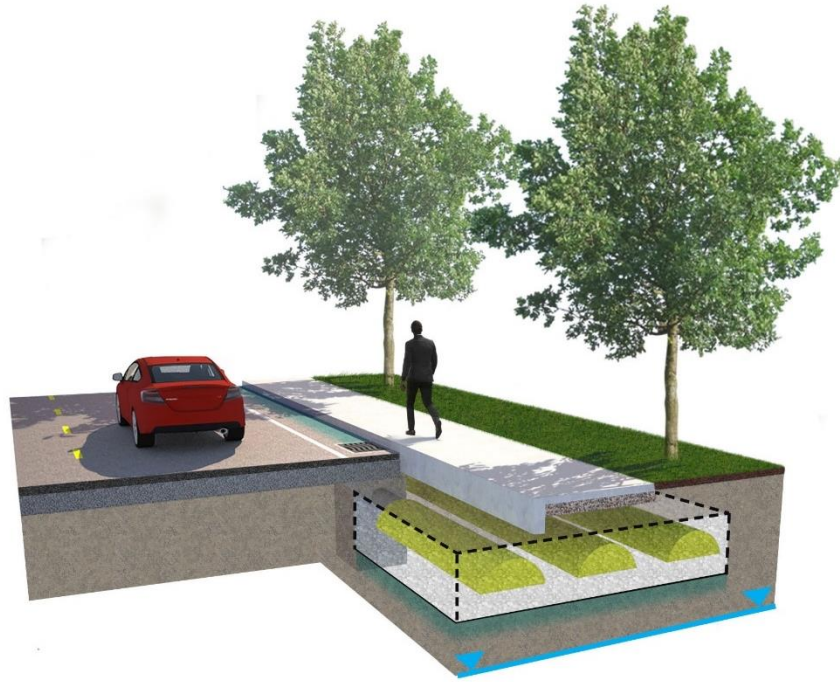
Figure 18: Subsurface infiltration chambers beneath sidewalk
