## Memorandum

Re: Wetlands Investigation  
AP 7 Lots 23 and 24  
Coventry, Rhode Island

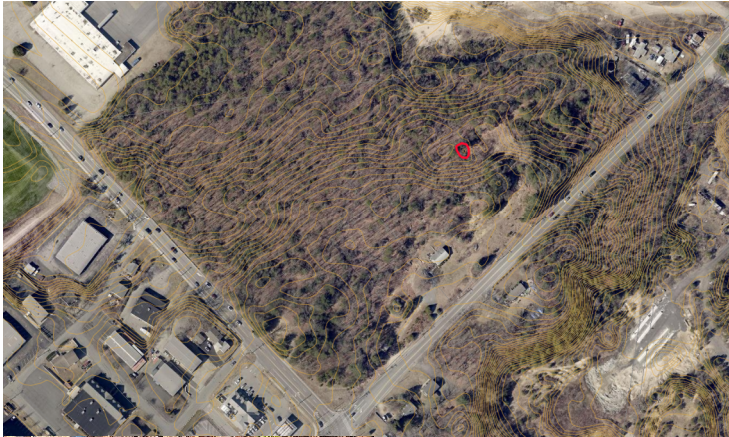
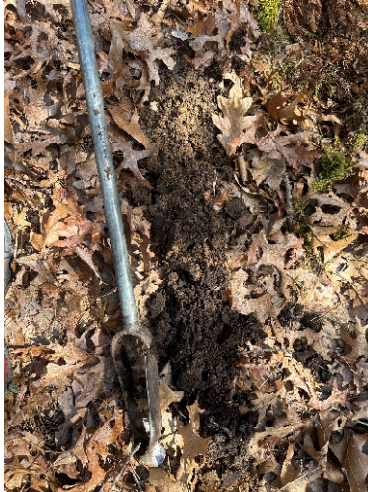
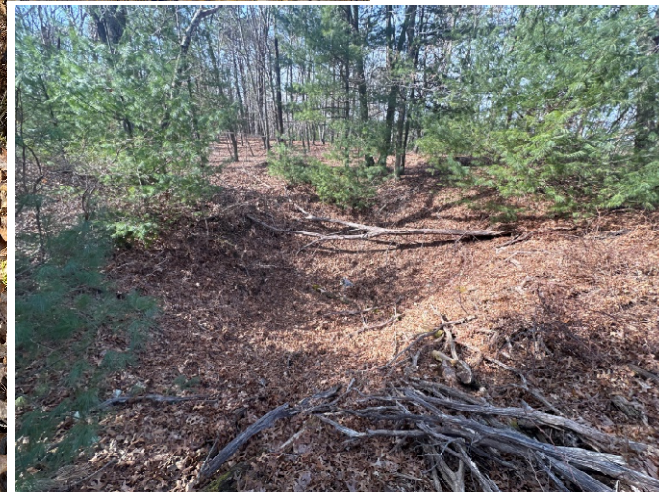
An approximately 12-15 foot deep and 40 foot wide depression was observed on Assessors Plat 8 Lot 24 (see attached photos). There was no vegetation within the depression. Indicators of wetland hydrology including surface water, watermarks, or water-stained leaves were not observed. A profile of the soil at the bottom of the depression was observed in the field and described as follows:

No indicators of hydric soils were observed in the soil profile described.

Due to the lack of hydrophytic vegetation, hydric soils, and other indicators of wetland hydrology, this depression is not a wetland resource.
